Inspection Report Minerals Regulatory Program August 11, 2011

Mine Name: Maynard Topaz	Permit Number: S/023/0099
Operator Name: : Colorado Calumet Co. Inc	Inspection Date: August 10, 2011
Inspector(s): Wayne Western	Time: 2:00 – 2:50 PM
Other Participants: none	Mine Status: ACT

This was a phase I bond release inspection.

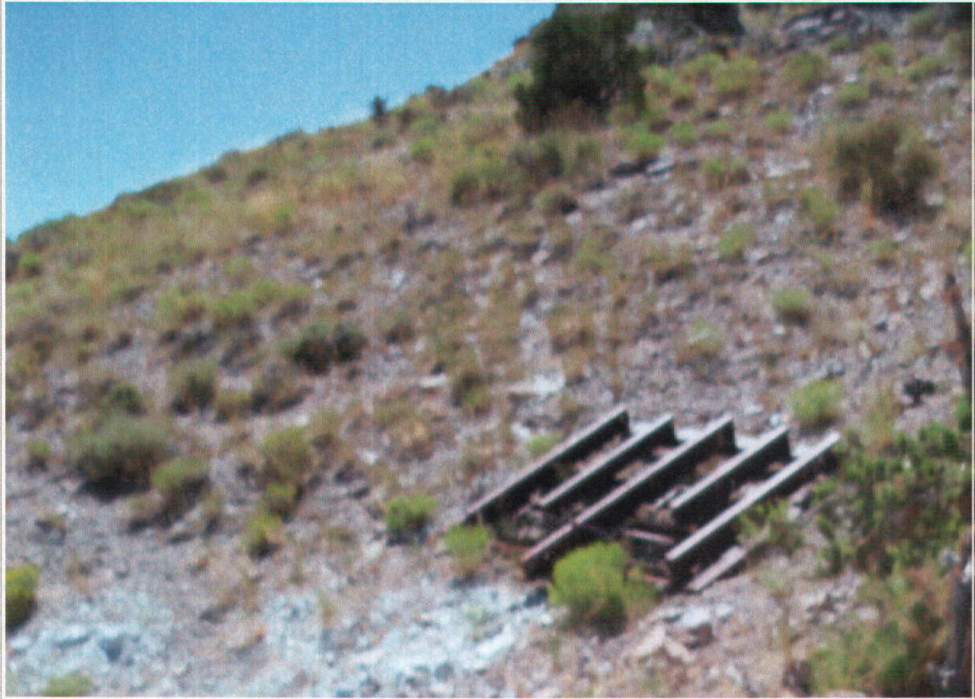
There is a grizzly left on the site, see page 3. The structure is steel and inert. The structure should be removed before bond release is granted.

Grizzly left on site.

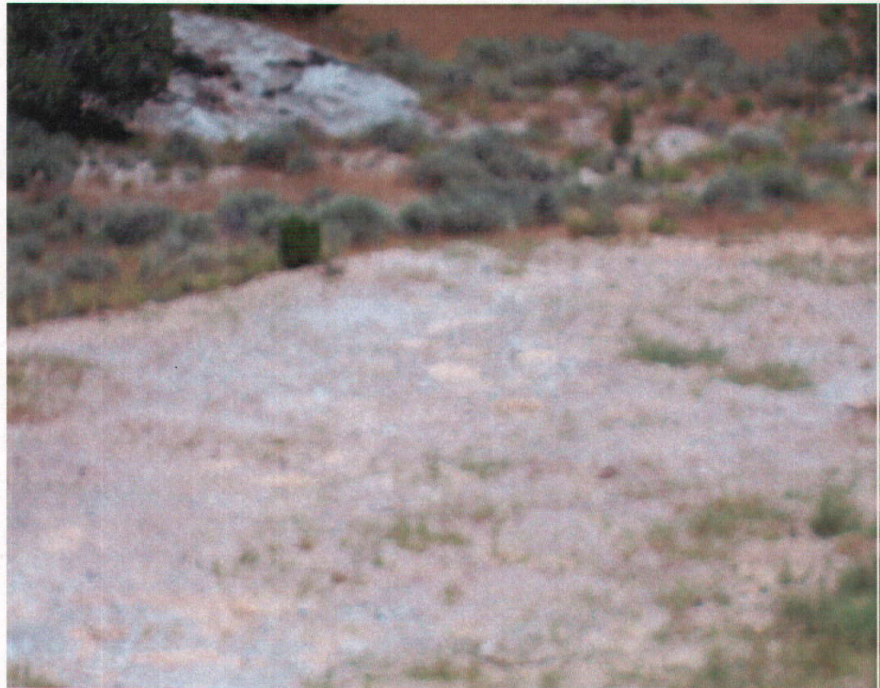
There were no roads on the site; rather the Operator drove equipment on the pad area. The pad area has been reclaimed. There is a road to the site but that was outside of the permit area.

Reclaimed pad area.

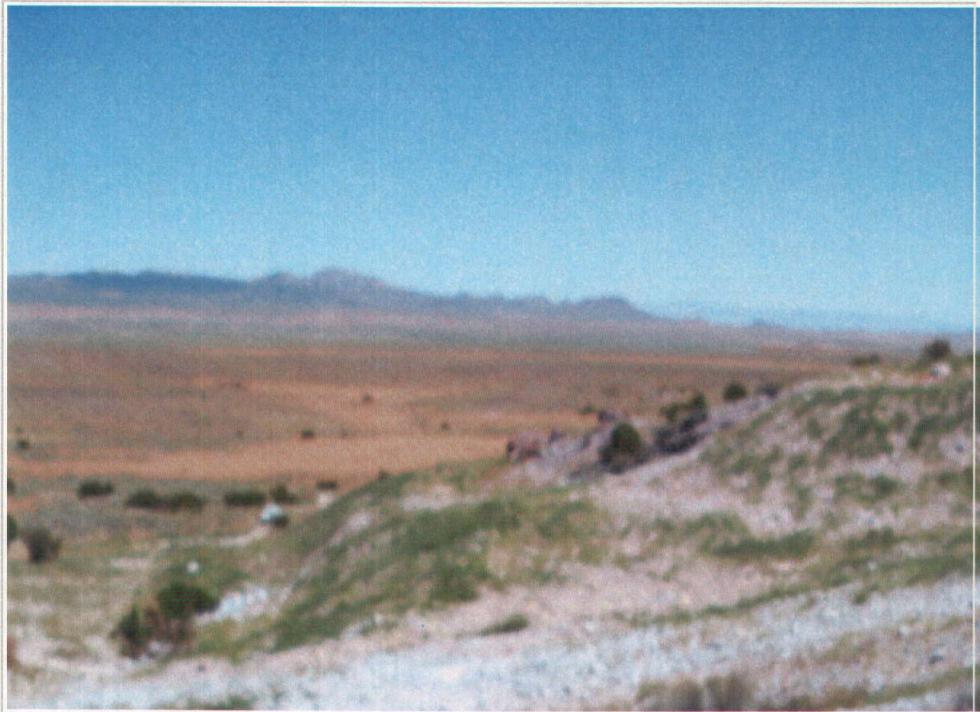
The Operator stated in the annual report that all stockpiled soils were placed during reclamation. The Operator stated in the 2010 annual report that they seeded in late spring 2010. Late spring is not an optimal planting time. There was no or little vegetation on much of the reclaimed area. Additional seeding may be required.

Reclaimed area.

The Division should grant phase I bond release. The Division should hold enough money to cover revegetation efforts. Since the Operator seeded in the late spring and there was little to no vegetation on the reclaimed areas during a year with abundant rainfall. Most likely additional seeding will be needed.

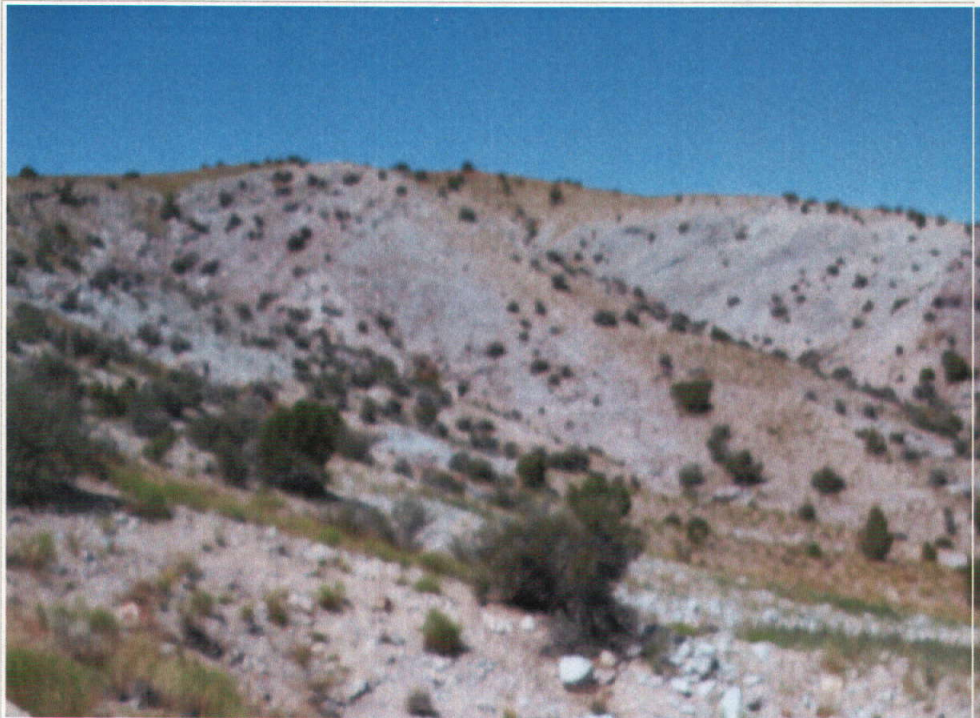
There were no shafts or adits on the site. The highwalls have been backfilled and graded. There is an old sign stating that no digging is allowed on the site.

Reclaimed highwalls
